Enforcement Integration of the Overheight Vehicle Detection System (OVDS)

Houston, Texas

Report 409193-1

Lessons Learned Report in Houston, Texas

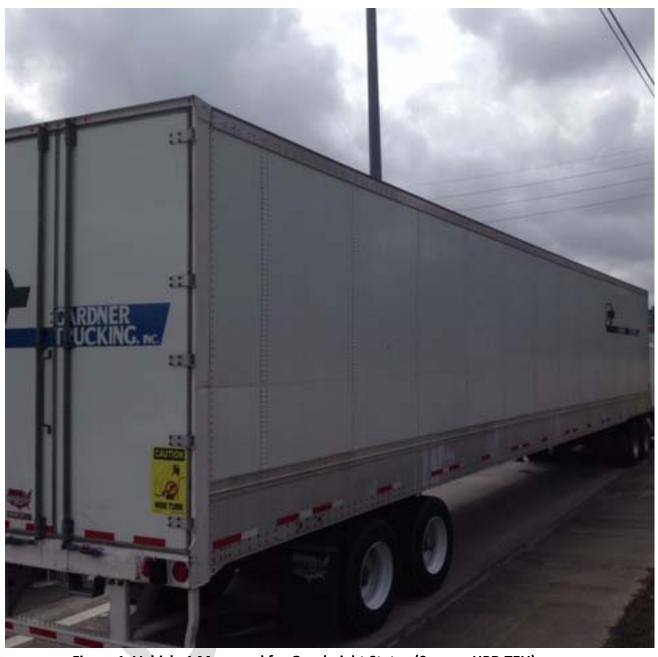
On Feb 29th, 2016, HPD officers stopped a couple of overheight vehicles (vehicles that triggered the overheight sensor and activated the DMS) and measured their height. Both vehicles were found to be 14'1" high (see Figure 1 thru Figure 4), thereby assuring the project team and enforcement officers that OVDS was accurate in detecting overheight vehicles.

Figure 1. Vehicle 1 Measured for Overheight Status (Source: HPD TEU)

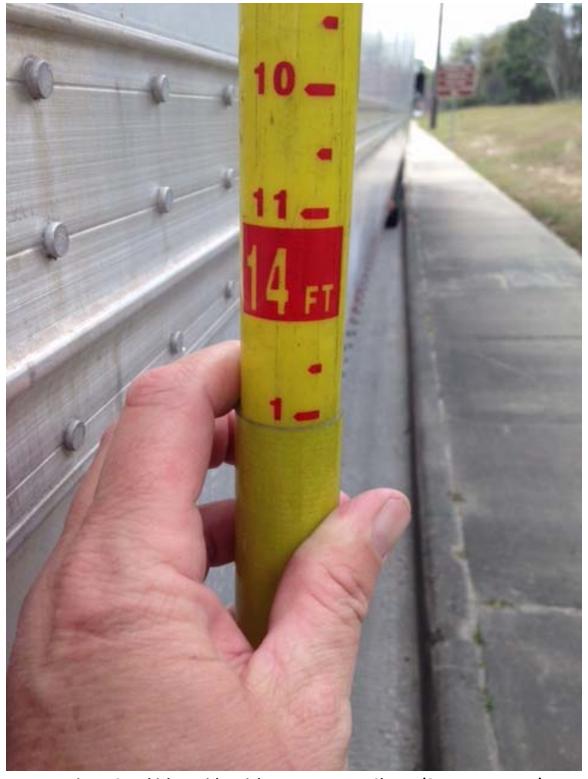
Figure 2. Vehicle 1 with Height Measurement Shown (Source: HPD TEU)

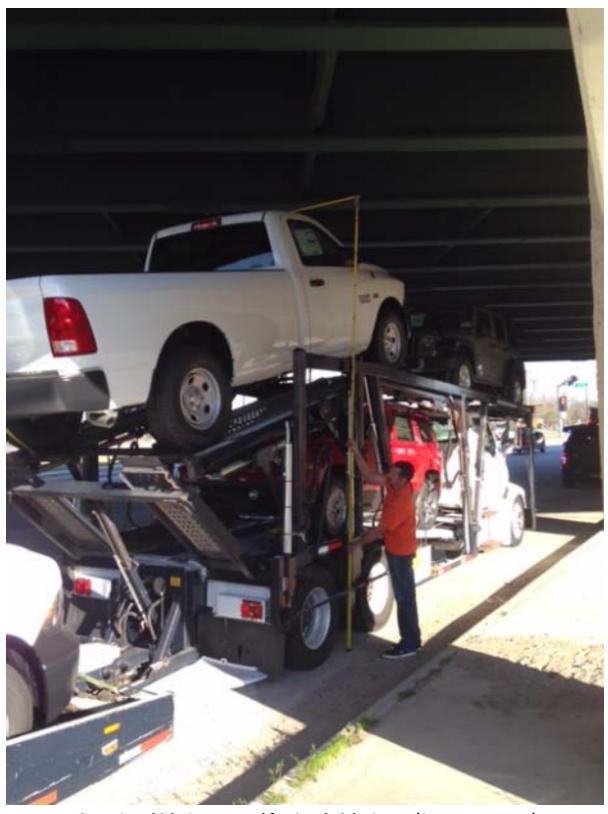
Figure 3. Vehicle 2 Measured for Overheight Status (Source: HPD TEU)

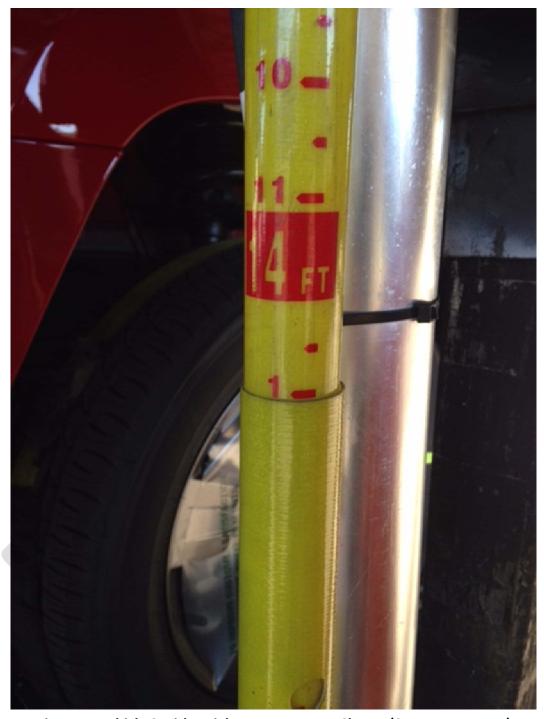
Figure 4. Vehicle 2 with Height Measurement Shown (Source: HPD TEU)
