**Evaluation of the Overheight Vehicle  
Detection System (OVDS)  
Houston, Texas**

Prepared by  
TEXAS A&M TRANSPORTATION INSTITUTE  
COLLEGE STATION, TEXAS

For the  
TEXAS DEPARTMENT OF TRANSPORTATION  
Houston District

Report 409193-1

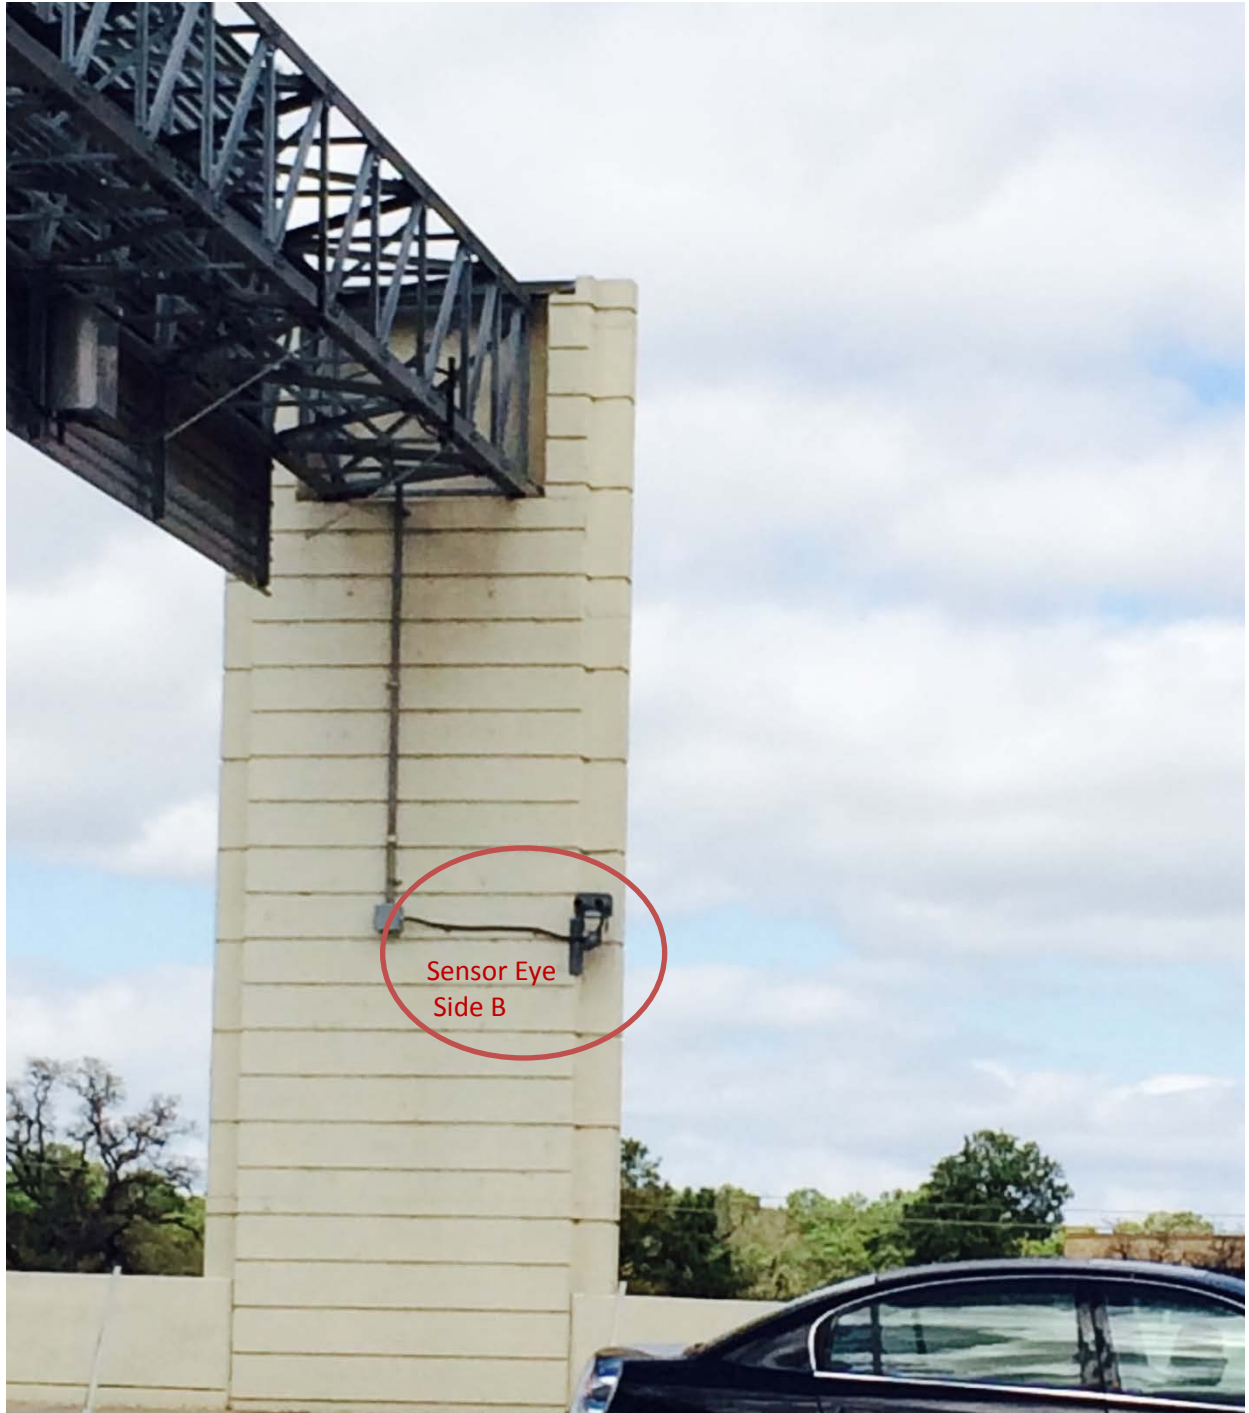
**Figure 2. OVDS Components at Wirt Site (on centerline of I-10).**

The OVDS system deployed for pilot demonstration in Houston, Texas consists of following components shown in Figure 1 thru Figure 3:

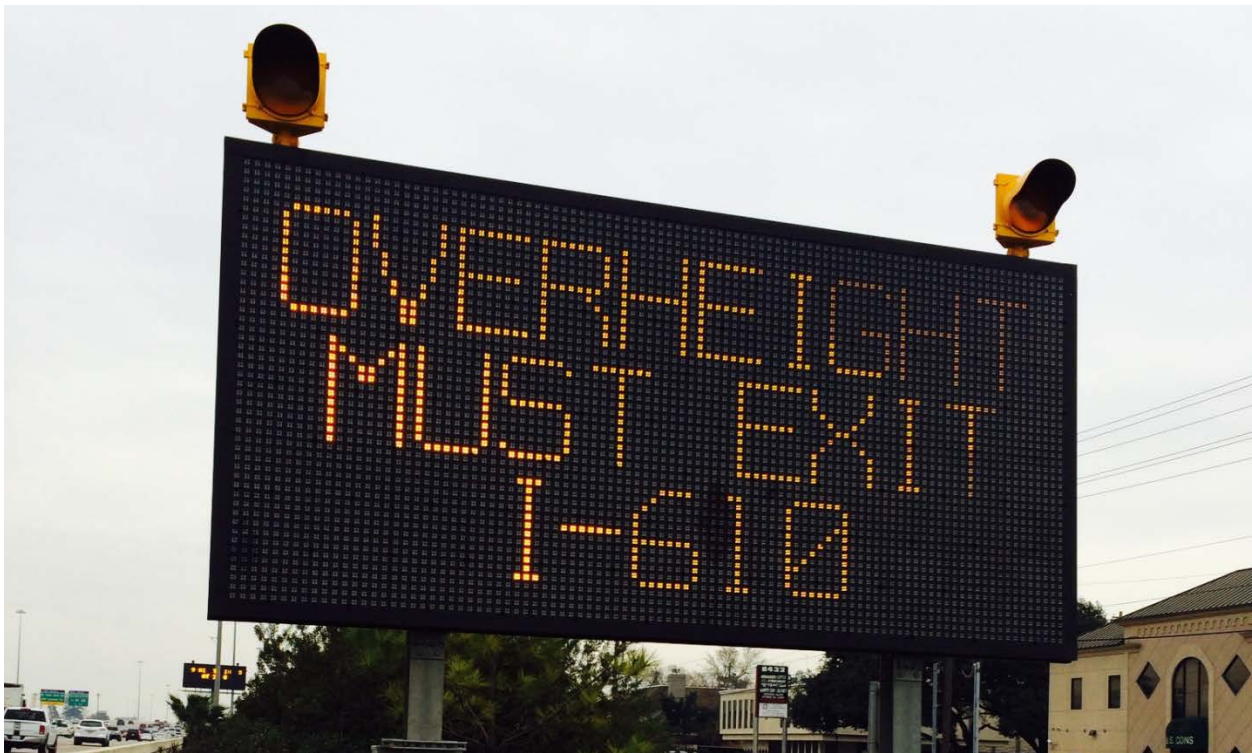
**Figure 3. DMS with Top Mounted Beacons Showing the Warning Message.**

For the pilot project, a DMS with top-mounted flashing beacons was preconfigured with the message 'OVERHEIGHT MUST EXIT I-610' (see Figure 3) to be displayed for 30 seconds. The DMS operated so that the flashing beacons become active as soon the contact closure signal is received by the DMS assembly. The DMS board is always on with a blank message in order to shorten the start-up and activation time between communications from the overheight sensor system to when the message displays. The time between contact closure to the display of the warning message is less than 1.0 second. The displayed message is a single phase message with 2 units of information and meets the Texas Manual on Traffic Control Devices (TxMUTCD) legibility and visibility requirements for changeable message signs. The DMS board is photocell equipped to provide the correct brightness and visibility for both during daytime and nighttime operations.

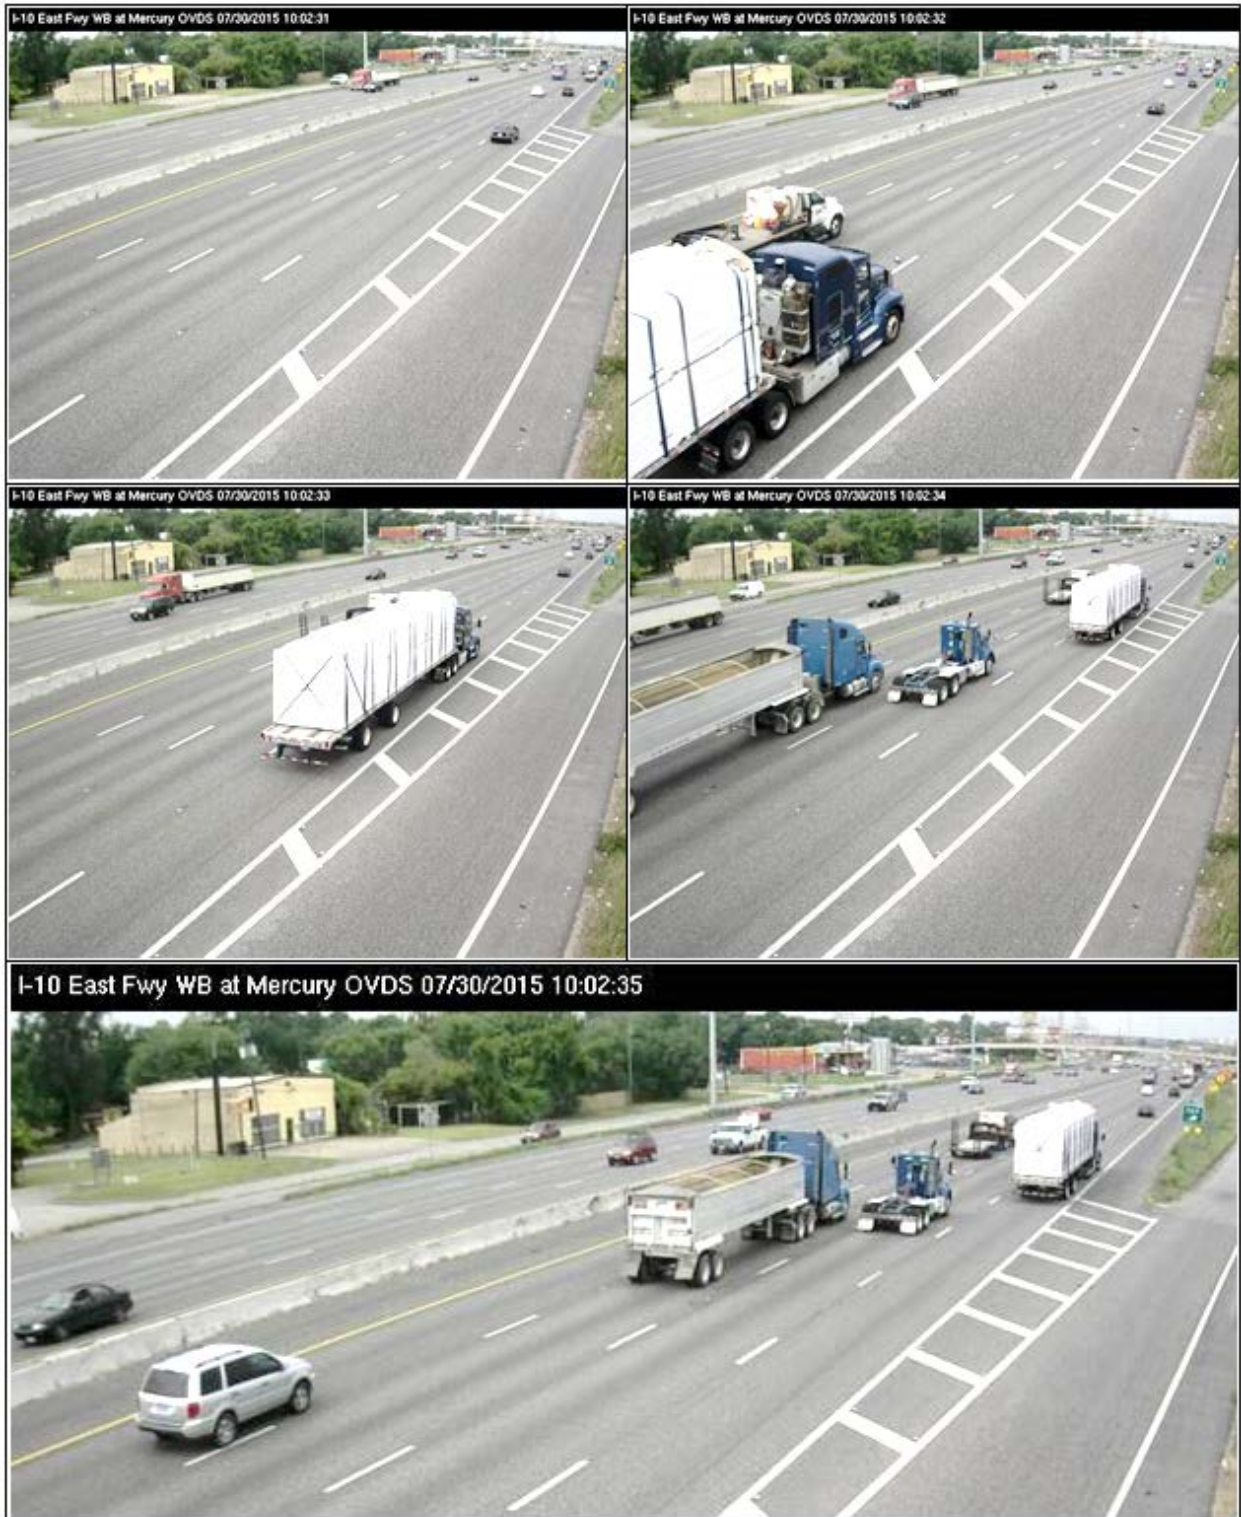
Figure 4. Example of Pictures Received in the Email Alarm Alert

1. The integrated camera takes a series of snap-shots (5 pictures taken one second apart) of the roadway downstream of the sensor (pre-set view) that are attached to the email alert sent to a pre-designated server or individuals if so configured. For this pilot demonstration, email alerts from the OVDS were sent to a server that in turn was configured to send these email alerts out to individual email addresses. Figure 4 shows an example of five pictures received in an email alert.

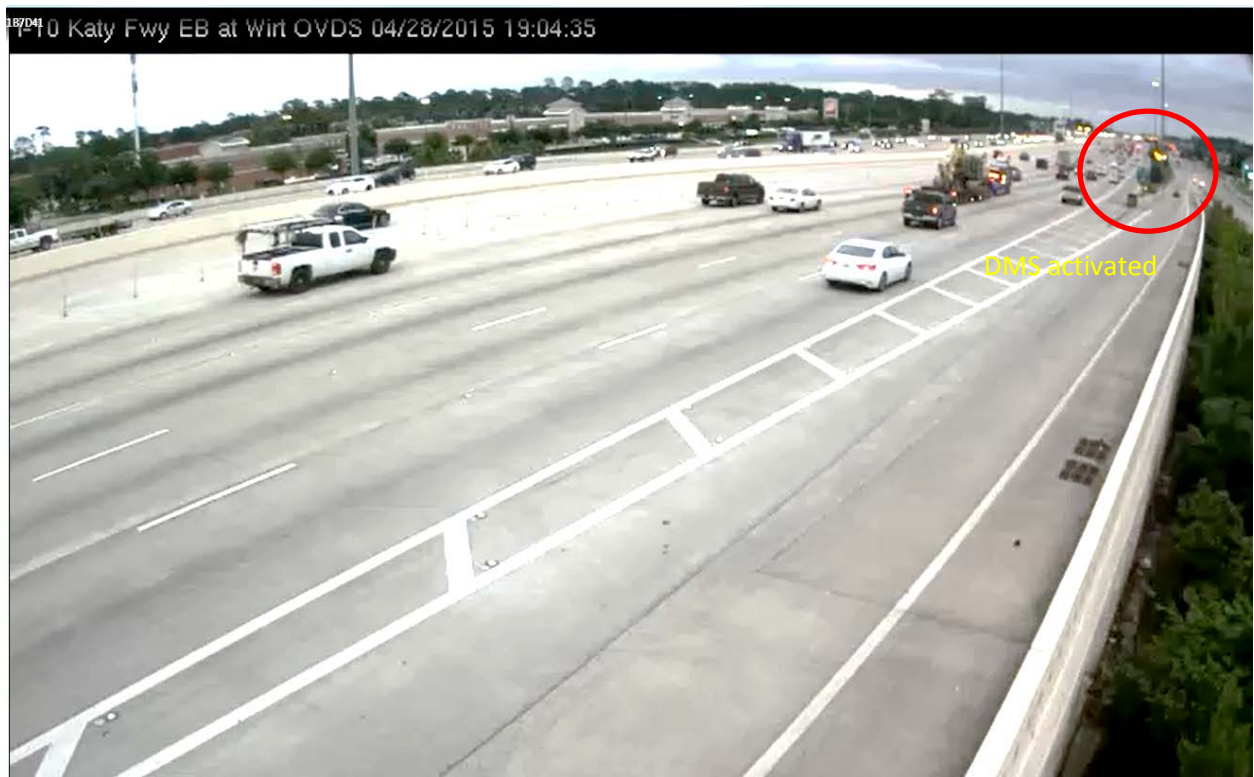
**Figure 8. Screen Capture from Sensor Video Showing Active Downstream DMS.**

After a considerable thought, it was decided to examine video from the sensor camera to visually confirm if the DMS was activated upon alarm transmittal. The sensor camera at both sites is aligned such that DMS sign activation is recognizable in the camera view. Figure 7 shows a screen capture of the alert video taken at the start of the video when DMS was not yet activated and Figure 8 shows a screen capture of the same alert video showing an activated DMS. Figure 7 and Figure 8 are meant to illustrate that the video from the sensor camera was able to show the DMS in its inactivated (dark) state and its activated state. The difference between time stamps of the two pictures is not meant to represent the actual time it takes to activate the DMS. The time between contact closure and DMS activation is less than 1.0 second.

- *Based on a visual examination of the alert videos, the downstream DMS was activated for each of the 125 alarms examined from both sites.*
- *No discrepancies between sensor and DMS communications were found for each of the 58 alarms examined at the Mercury site and each of the 67 alarms examined at the Wirt site.*

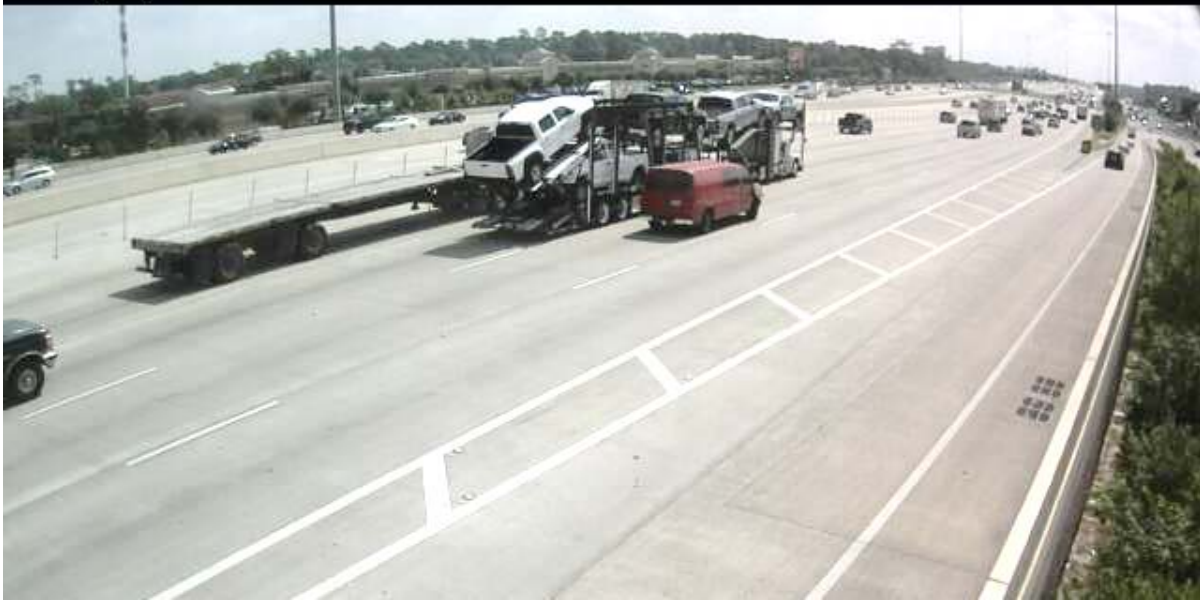
I-10 Katy Fwy EB at Wirt OVDS 07/24/2015 10:53:02

**Figure 9. Car Carrier Detected as Overheight at the Wirt Site.**

Figure 9 thru Figure 11 present pictures of overheight vehicle types that were seen more often in the email alerts than any other type of overheight vehicles.

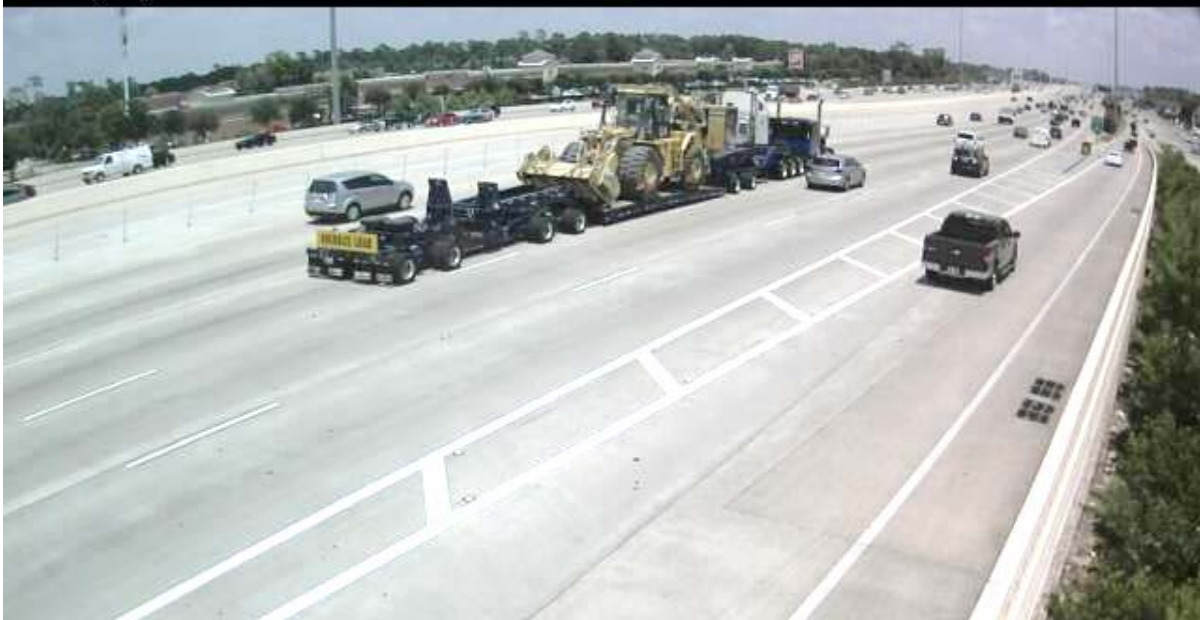
I-10 Katy Fwy EB at Wirt OVDS 07/24/2015 14:10:25

**Figure 10. Designated Oversize Load Detected as Overheight at the Wirt Site.**

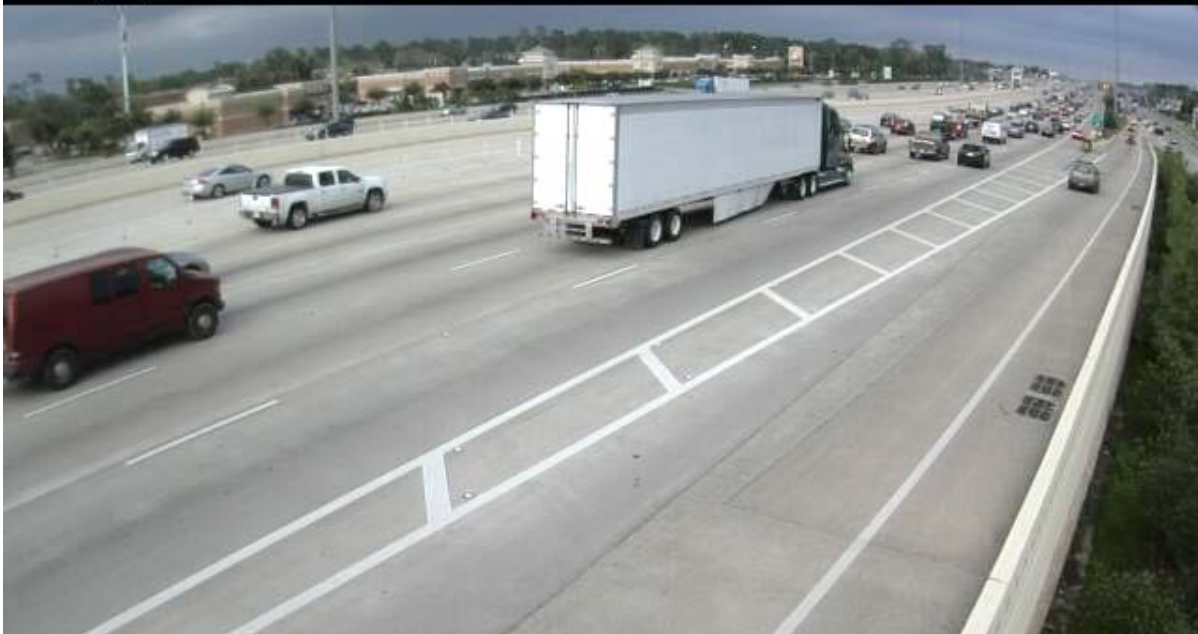
I-10 Katy Fwy EB at Wirt OVDS 03/19/2015 18:32:09

**Figure 11. Closed Cargo Truck Detected as Overheight at the Wirt Site.**

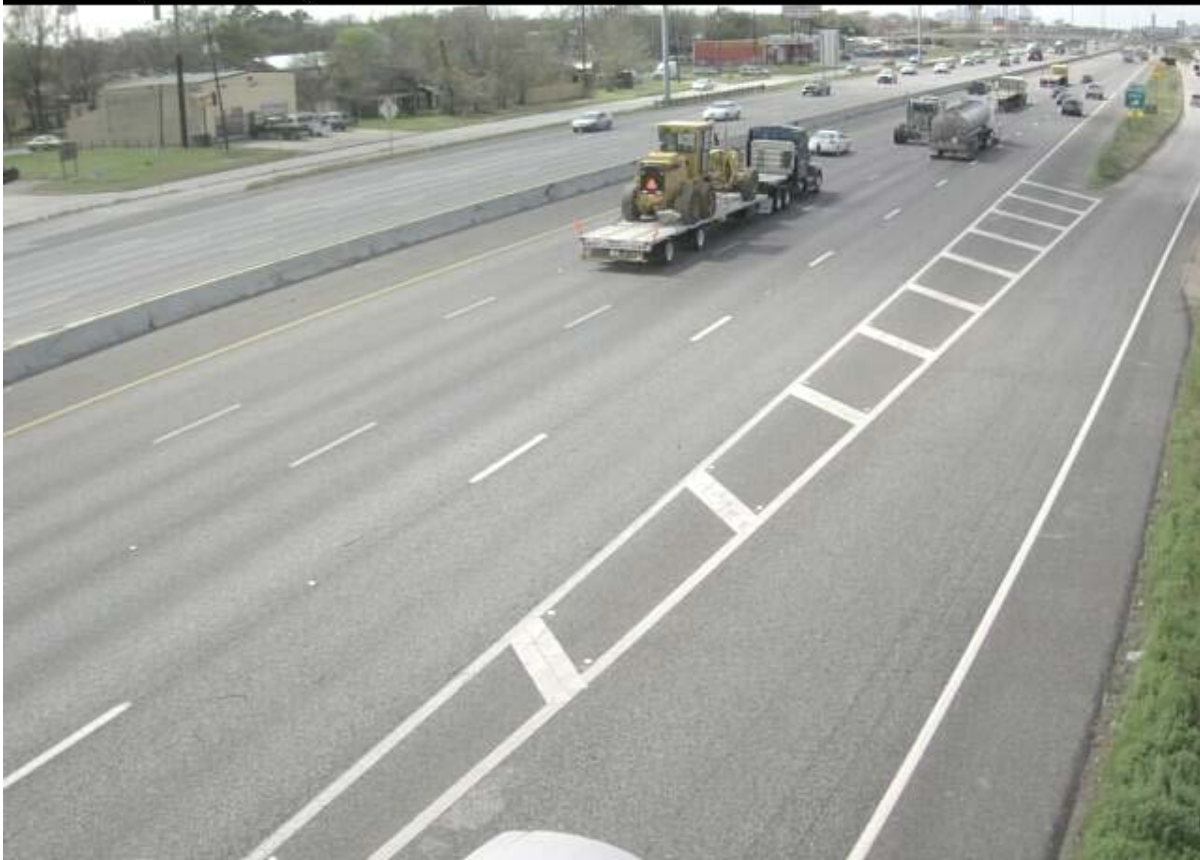
**Figure 12. Lowboy Overheight Load at the Mercury Site (continued on I-10 Inside of I-610).**

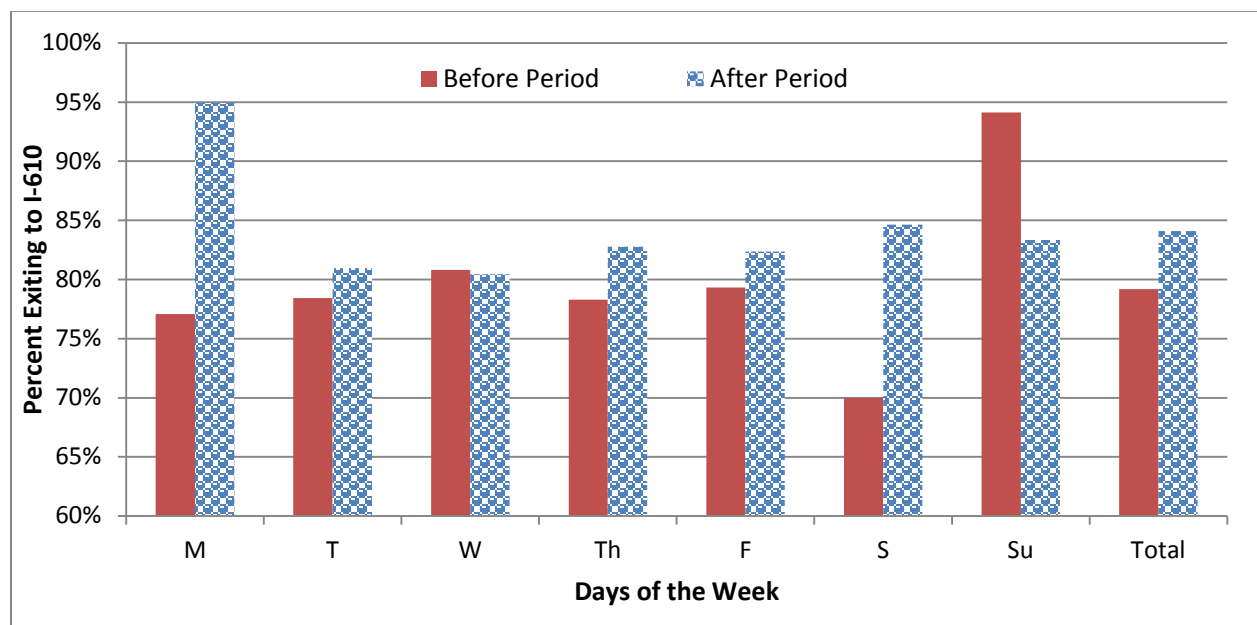
Figure 13. Percent of Overheight Vehicles Exiting to I-610 by Day of the Week at Mercury Site

Figure 13 presents the percent of overheight vehicles exiting to I-610 by day of the week (and total for all days) analyzed at Mercury site.

Table 12 shows the number of overheight vehicles at Mercury site by route for each of the dates for which video data were analyzed. The percentage of overheight vehicles exiting to I-610 increased or stayed the same for every day of the week except Sunday. The overall proportion of overheight vehicles exiting to I-610 increased in the After period by approximately 5%. Using the Z-test on the proportions, researchers found that increase in proportions of overheight vehicles exiting to I-610 in the After period was not statistically significant at a 95% confidence level, but was statistically significant at a 90% confidence level.

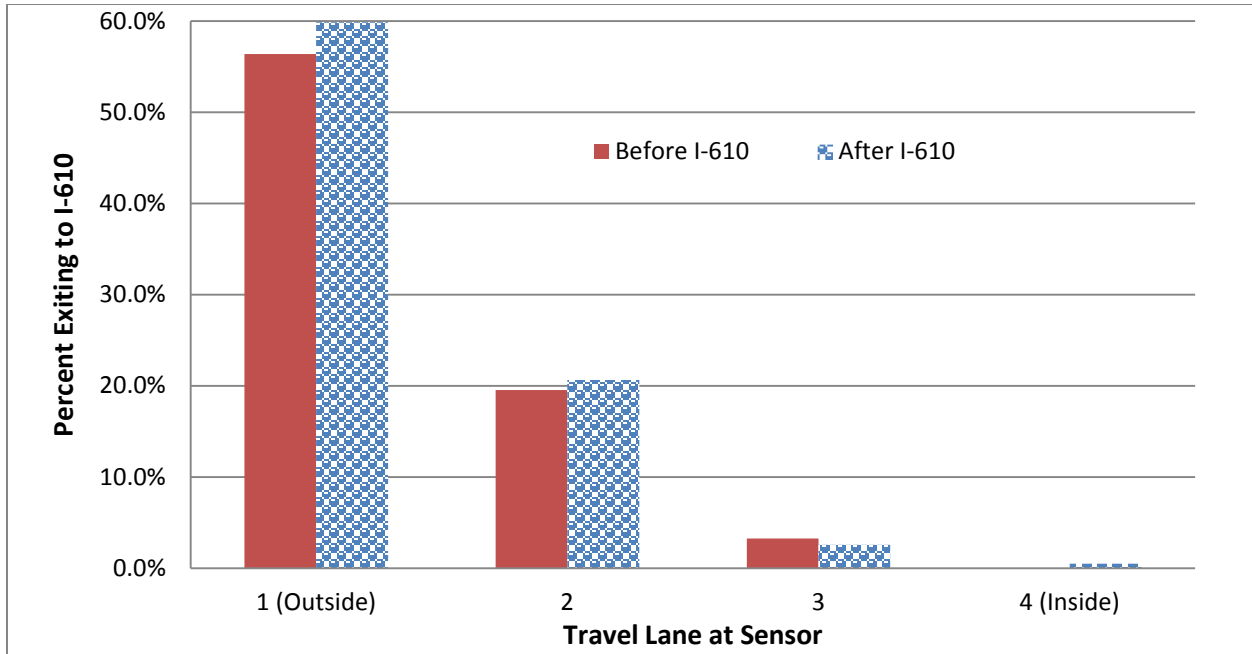
**Figure 16. Percent of Overheight Vehicles by Travel Lane at Sensor and Exiting to I-610 at Mercury Site**

Figure 16 shows the percent of overweight vehicles exiting to I-610 by travel lane at sensor in the Before and After period for Mercury site.

- Approximately 87% of overweight vehicles were traveling in the two right lanes at the sensor location both in the Before and After period. For this particular location, heavy vehicles traveling in the 2 right most lanes accounted for approximately 63% in the Before period and 66% in the After period of all heavy vehicles. The analysis suggests majority of overweight vehicles travel in the two right most lanes at this site which is not surprising considering Left lane at this location is restricted to truck traffic.

- The average number of lane changes per overweight vehicle exiting to I-610 in the After period increased to 0.62 as compared to 0.5 for the Before period. Based on the available data about number and travel patterns of overweight vehicles, DMS message compliance resulted in approximately three additional lane changes per day (23 overweight vehicles per day \* 0.12 additional lane changes/overheight vehicle = 2.8 lane changes per day). Researchers are of the opinion that three additional lane changes per day are not likely to cause any unintended safety concerns in the area between the sensor and interchange.

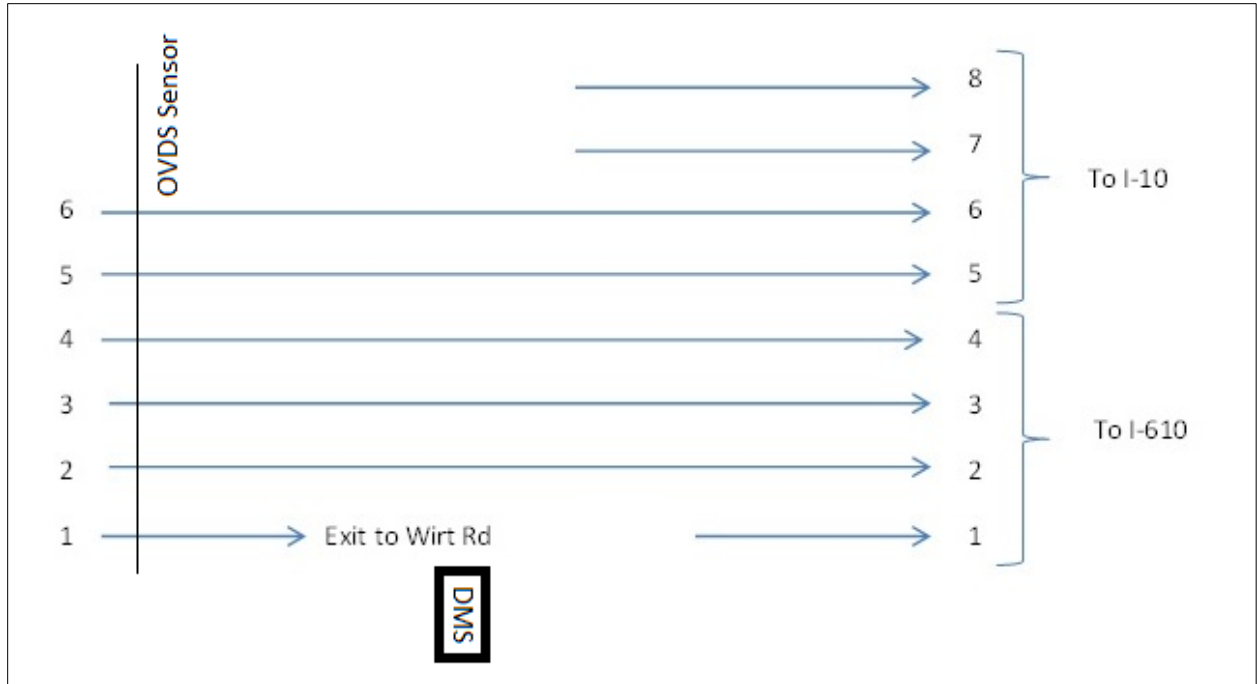
Figure 17. Lane Alignment with Lane Numbers from OVDS Sensor to Interchange at Wirt Site

Figure 17 shows lane alignment between sensor location and interchange, and the corresponding lane numbers. Table 17 shows the number of overheight vehicles by route (I-610 or I-10) and their travel lane at OVDS sensor, travel lane at I-610/I-10 interchange, and the number of minimum lane changes completed between the DMS and the I-610/I-10 interchange at Wirt site. To compute the average number of lane changes completed by an overheight vehicle between the sensor and interchange, it was assumed that an overheight vehicle will complete the least amount of lane changes in order to reach its destination.

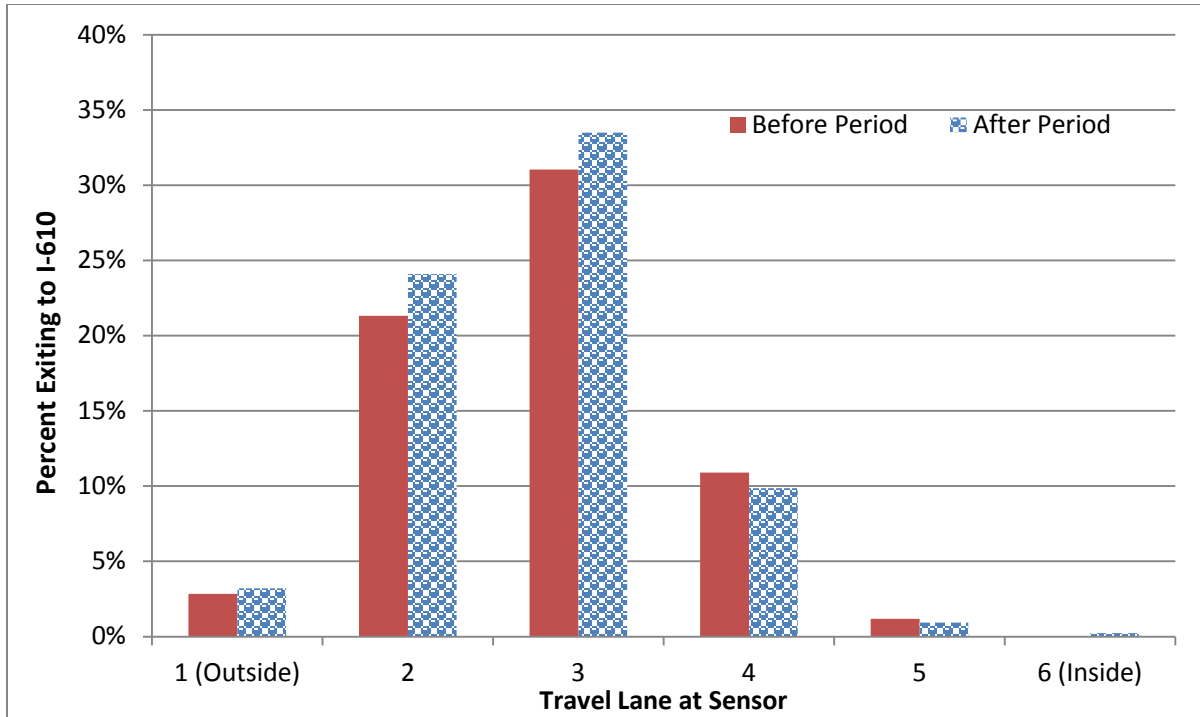
**Figure 18. Percent of Overheight Vehicles by Travel Lane at Sensor and Exiting to I-610 at Wirt Site**

Figure 18 shows the percent of overweight vehicles exiting to I-610 by travel lane at sensor in the Before and After period for Wirt site.

- The percentage of overweight vehicles traveling in the three right lanes that continue to I-610 and in the auxiliary lane was approximately 91% in the Before period and 95% in the After period. For this particular location, heavy vehicles traveling in the 3 right most lanes accounted for approximately 63% in the Before period and 62% in the After period of all heavy vehicles.
